Manhole Inspection Summary

Manhole # S49II_007MH

Insp Date: **5/14/08 1:24 PM**

Location Address: **Lakewood av**

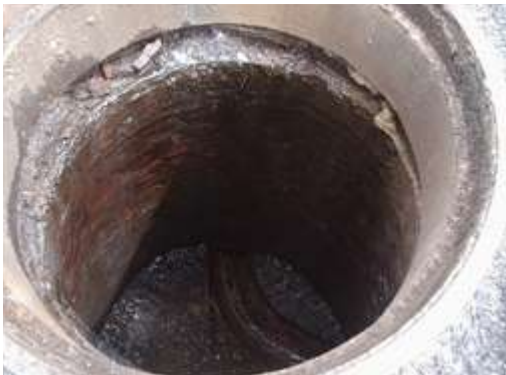
Defect 2

Condition: ☐ Sound ☐ Cracked ☐ Root Intrusion ☒ **Loose Brick** ☐ Deteriorated

loose bricks

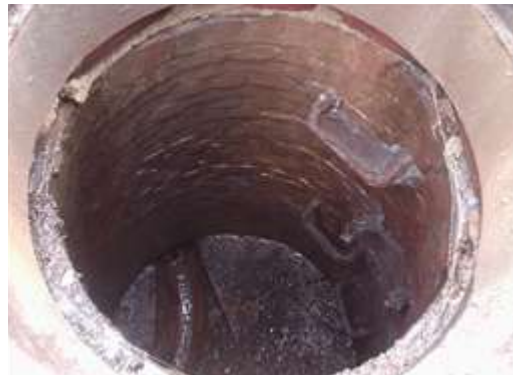
Defect 1

Infiltration: ☐ None ☒ **Joint** ☐ Cracks ☒ **Mortar** ☐ Roots ☐ Wall

infiltration

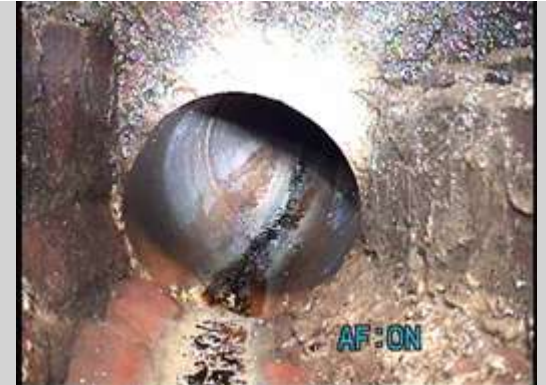
12 O'Clock Outflow

8 in. Circular Gravity Sewer
Pipe Out @ 12 O'Clock

Infiltration: **None** Pipe Seal Cond: **Sound**

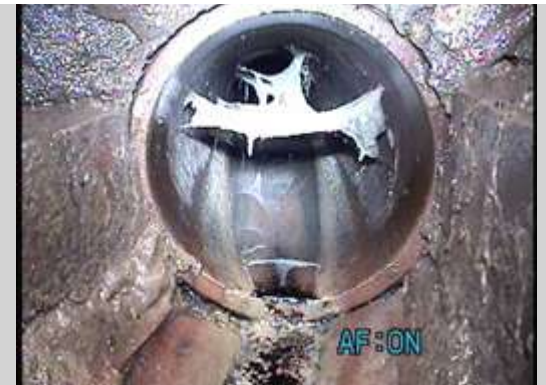
3 O'Clock Inflow

8 in. Circular Gravity Sewer
Pipe In @ 3 O'Clock

Infiltration: **None** Pipe Seal Cond: **Sound**
